# Bad Actor Elimination in Pumps

Vasanth Bhat and Thangavel Suthan  
Singapore Refining Company

# Case 1 : Slurry Bottoms Pump

# Case Study 2: Lean MEA Pump

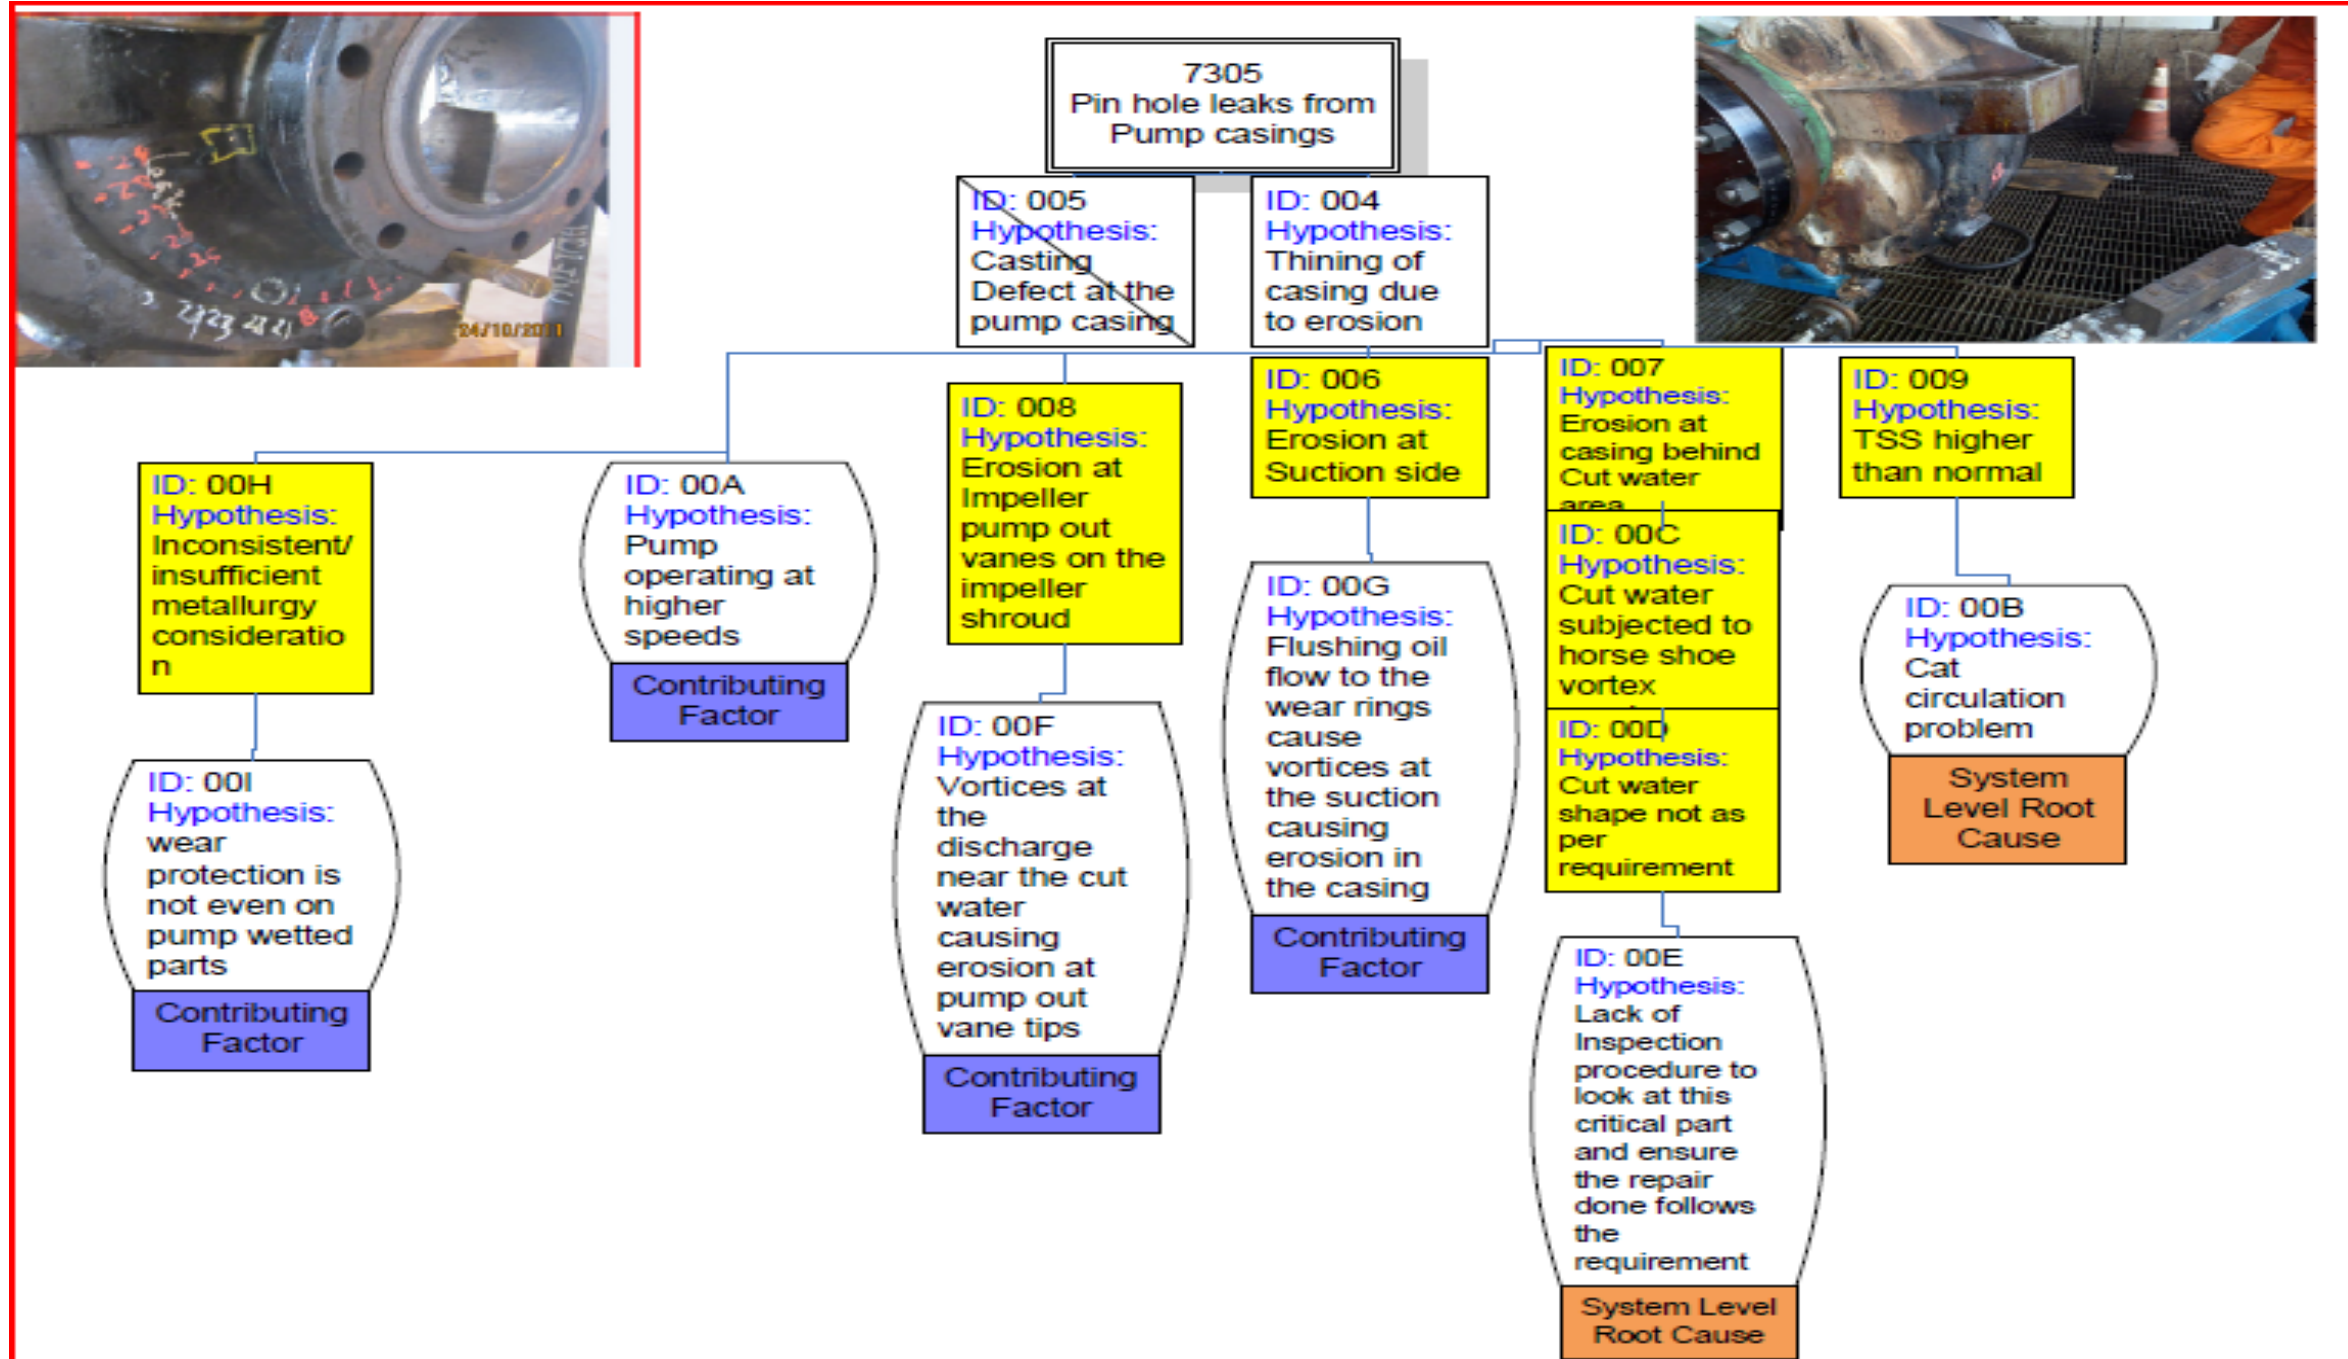
# Why Tree for Casing Leak Failure

- Researches has shown pump erosion has direct relationship with pump speed . Pumps running at lower speeds tend to have longer life.
- Due to abrasive solid pumping, these pumps are equipped with flushed wear rings. The concept here is that clean liquid is introduced into the wear rings annulus in an attempt to dilute the solids concentration and reduce the wear rate. Experience shows that the high intensity turbulence created by the flush flow can often be counterproductive. In fact, the additional turbulence can cause accelerated ring wear. Figure shows a typical flushed wear ring that exhibits the extreme damage that is often seen. Current recommendations is to stop the flushing oil flow and hence reduce the erosion.

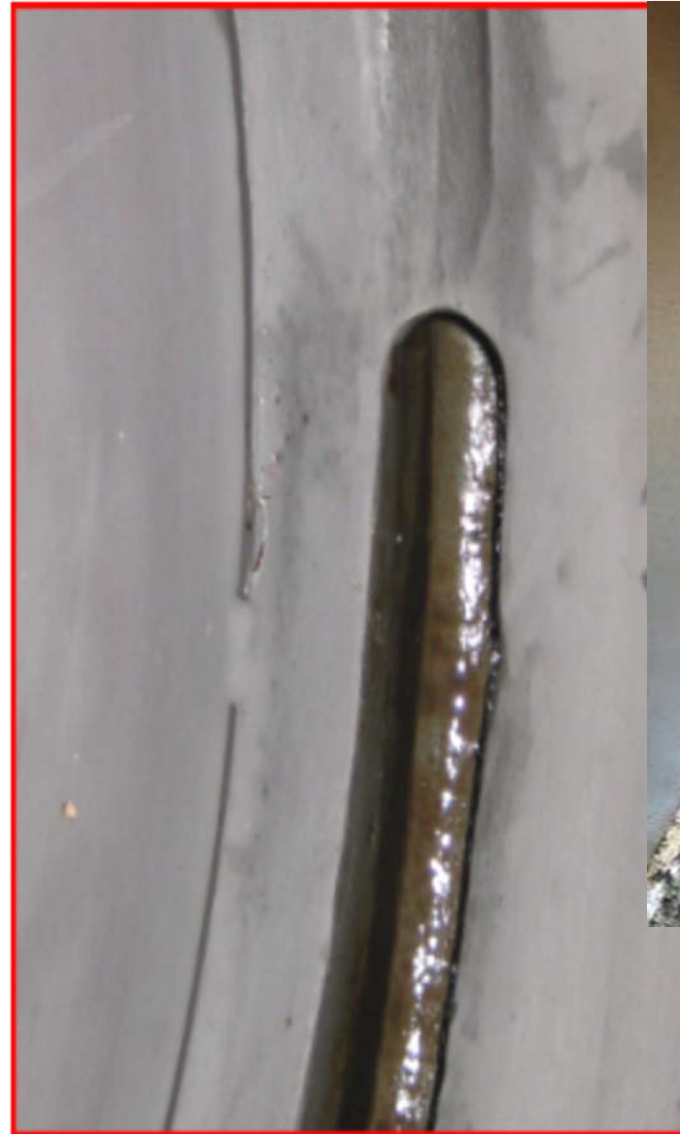
New Condition

Eroded cavity  
10mm deep x  
5mm width

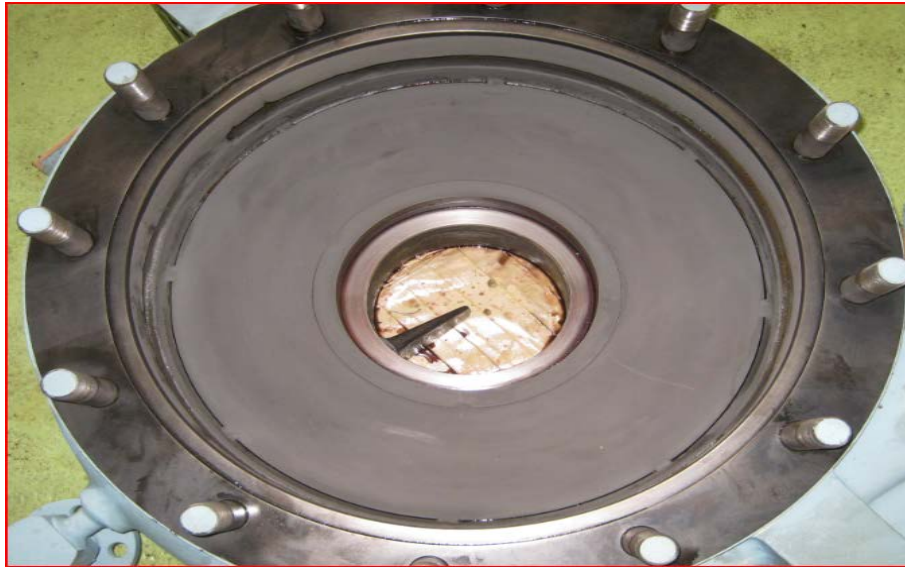
New  
Condition –  
WC Coated

- Shows erosion at cut-water exit area.
- Shows erosion pitting on volute area.

- Max size impeller to be stocked in warehouse. This would help to bring down the speed further.
- Tungsten carbide coating is effective so would remain the repair technique for present moment.
- To improve the cut-water erosion, a stellite insert will be used at the critical area.
- OEM has confirmed that the flushing oil to the suction wear ring could be stopped and the impeller back vanes could be removed without any effect to the pump bearings.

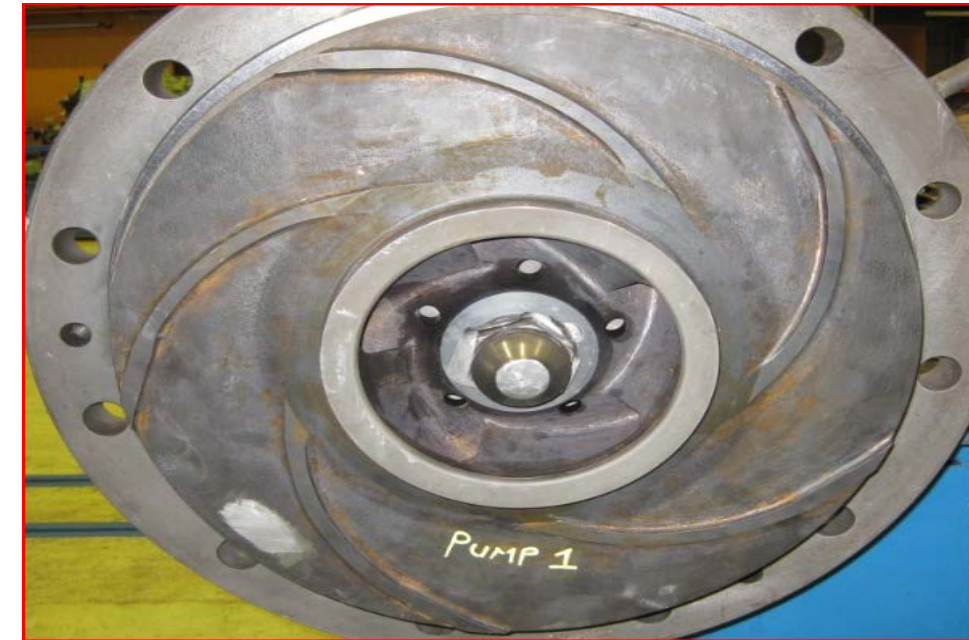
New  
Condition

Erosion at Pump out  
vane leading edge

Erosion at Wear-ring  
neck

- Shows initial stages of erosion at pump out vanes and impeller wear ring neck area.

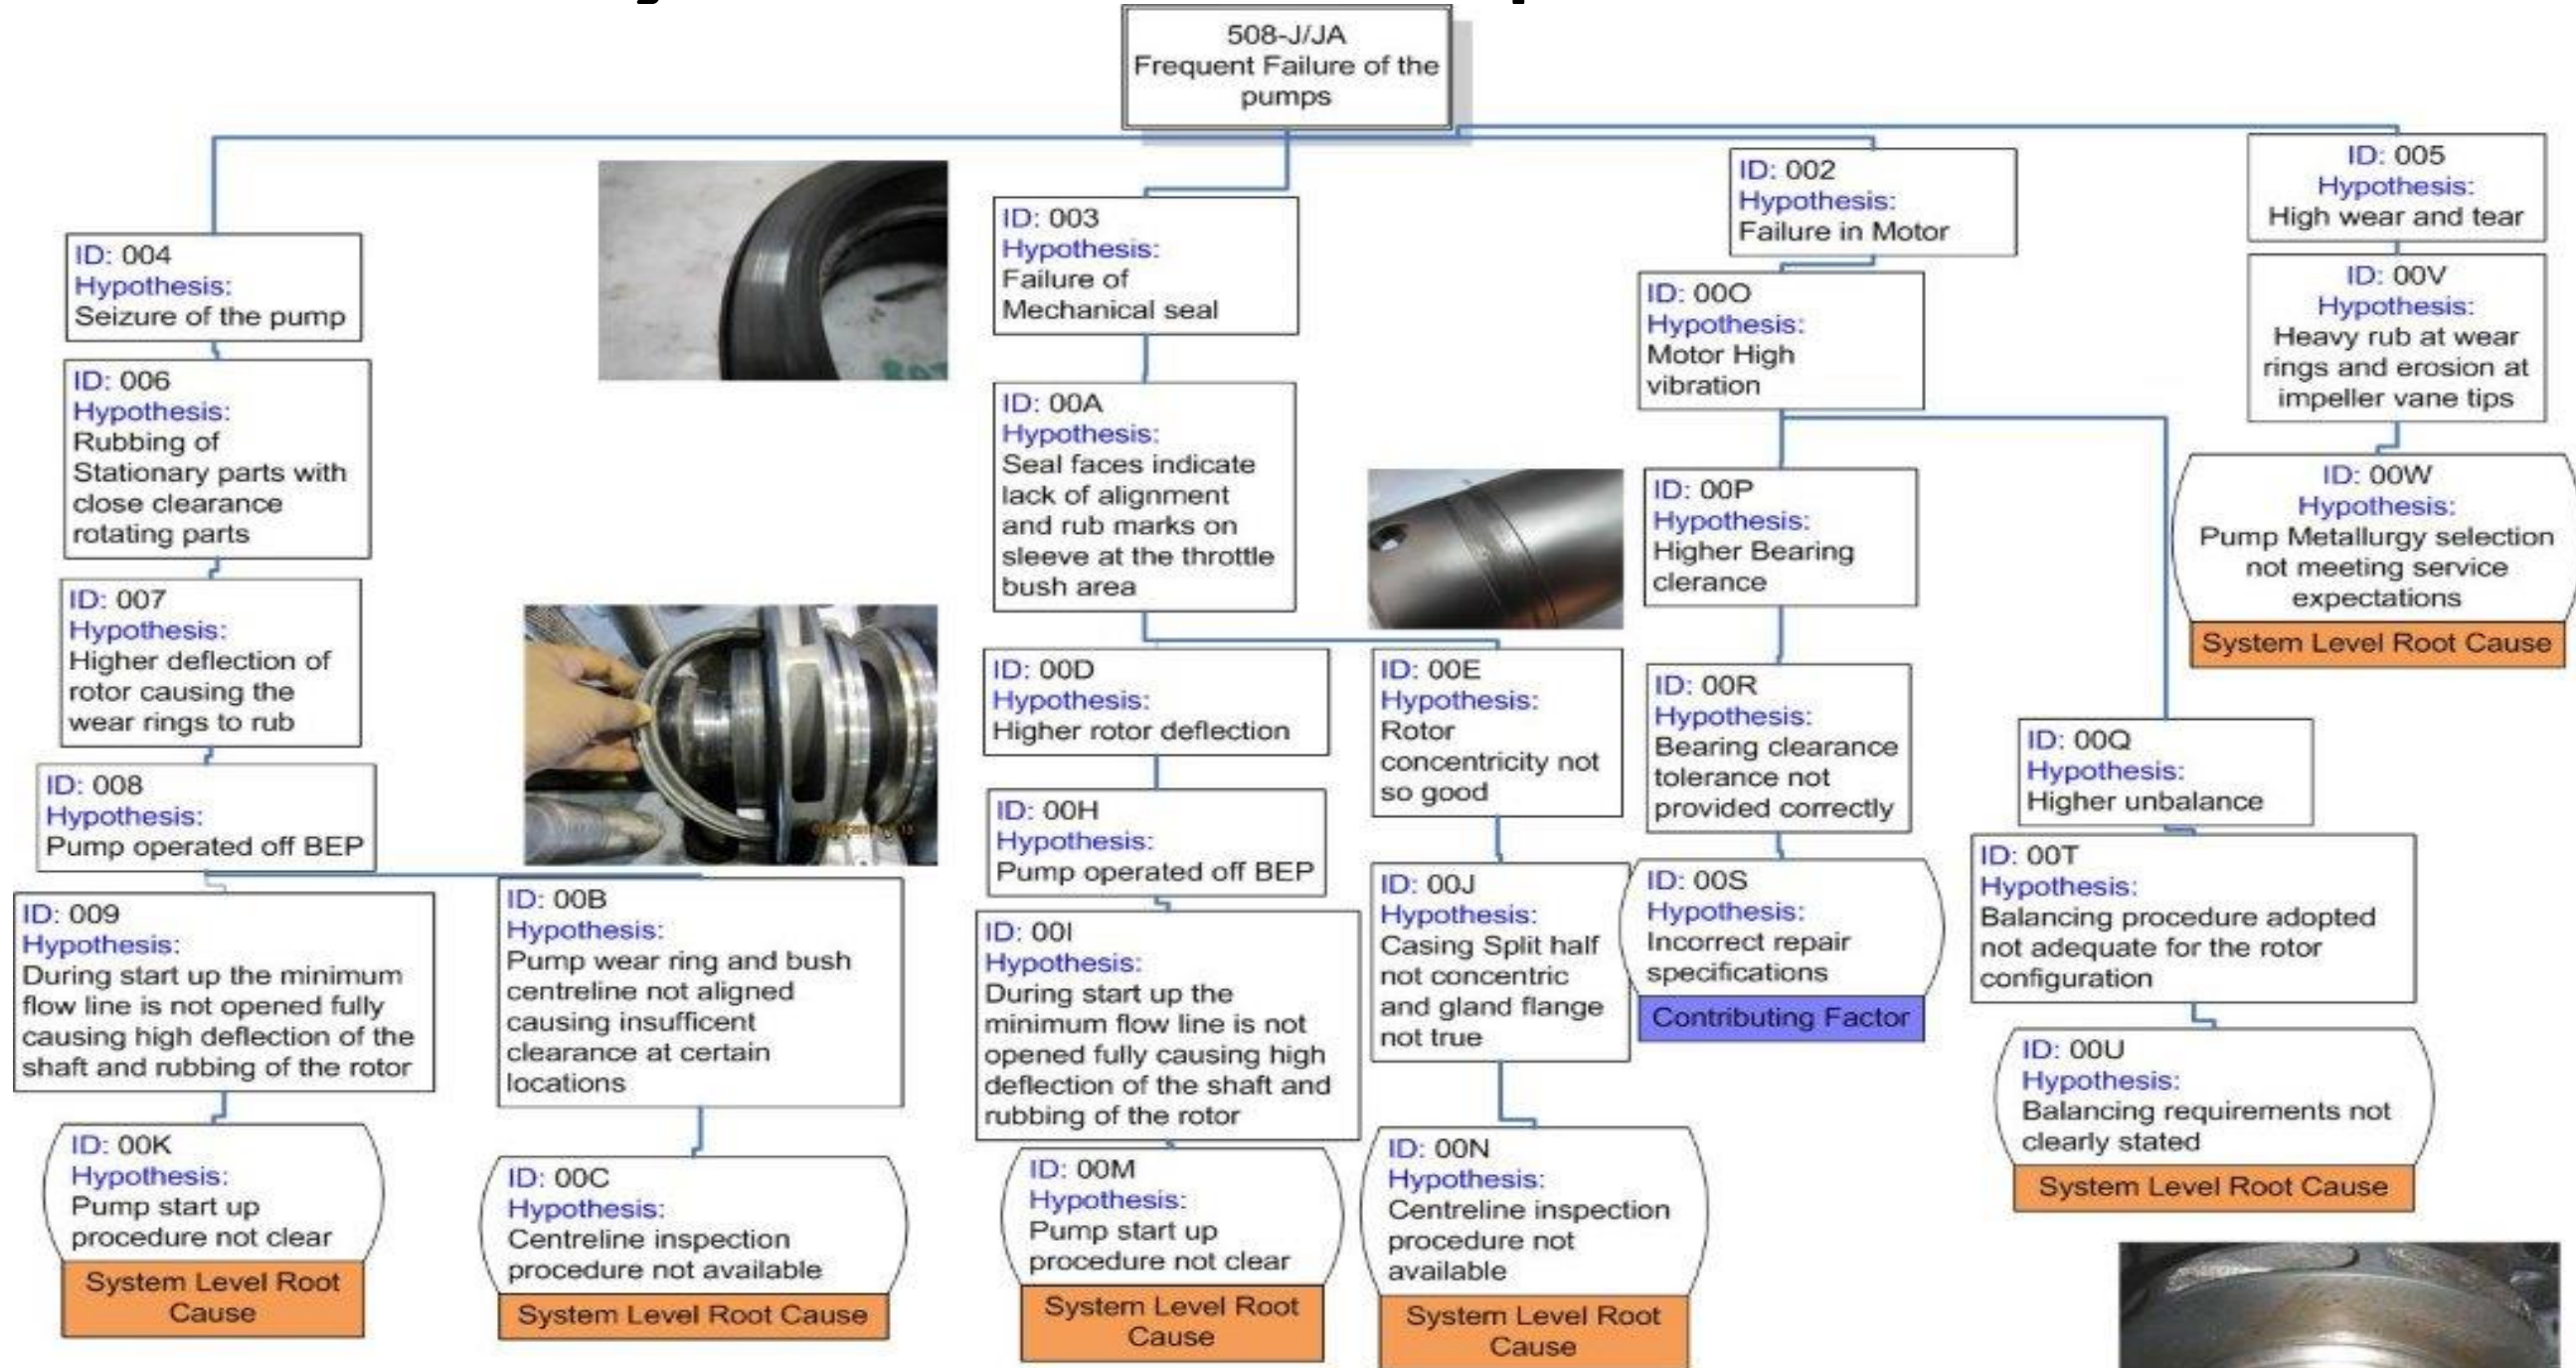
# Why Tree for Pump Shaft Failure

- Operation procedure of the pump during start up.
- Design of the pump vulnerable to seizure.
- Repair standards of the pump not the levels expected.

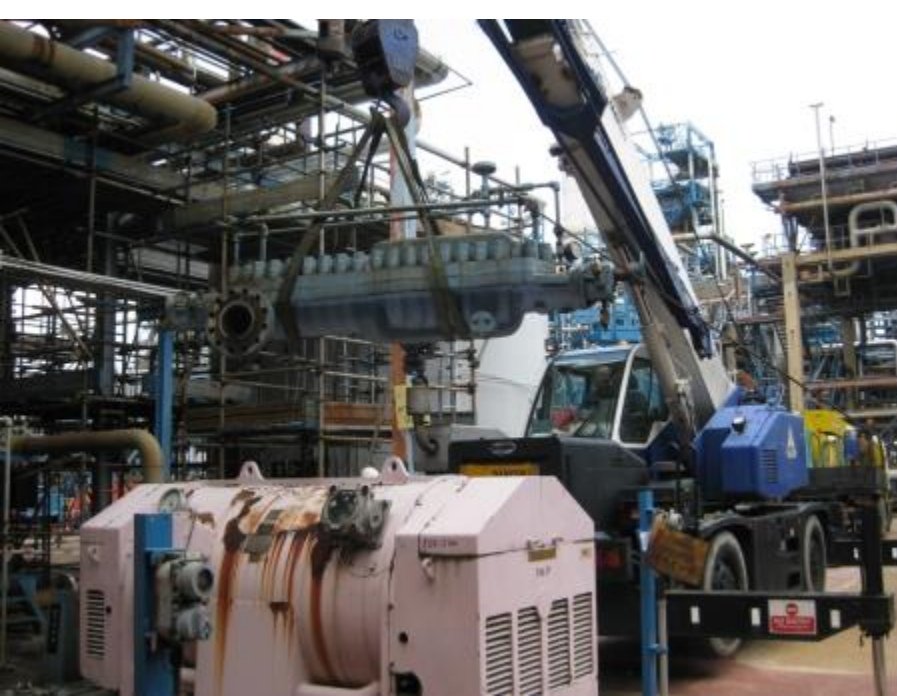
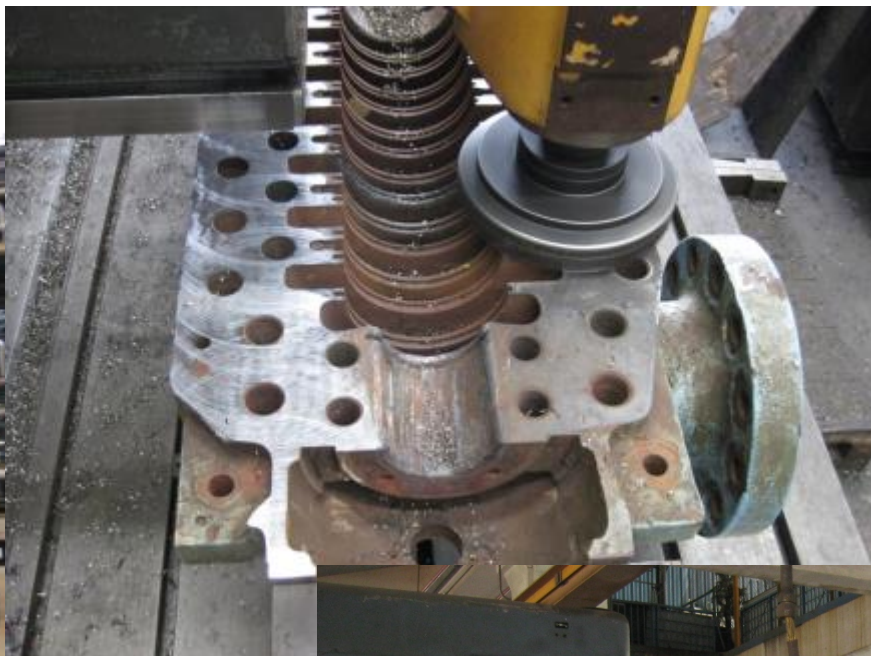
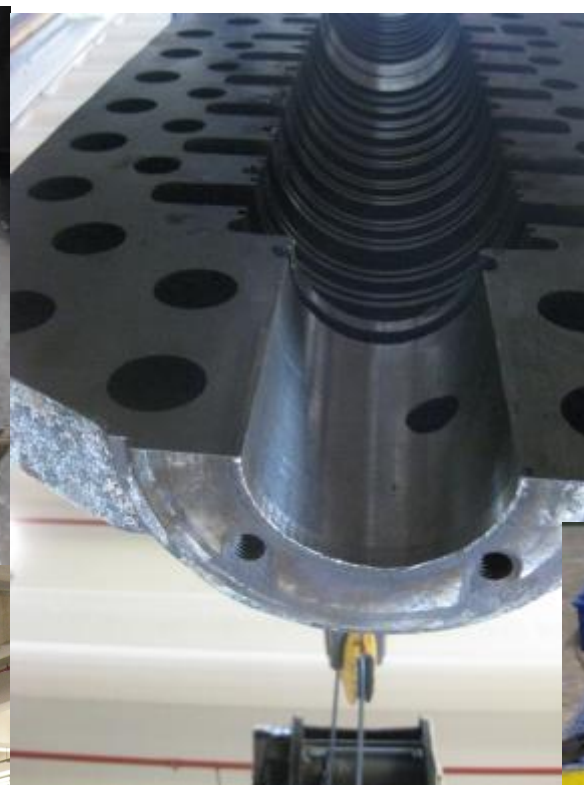
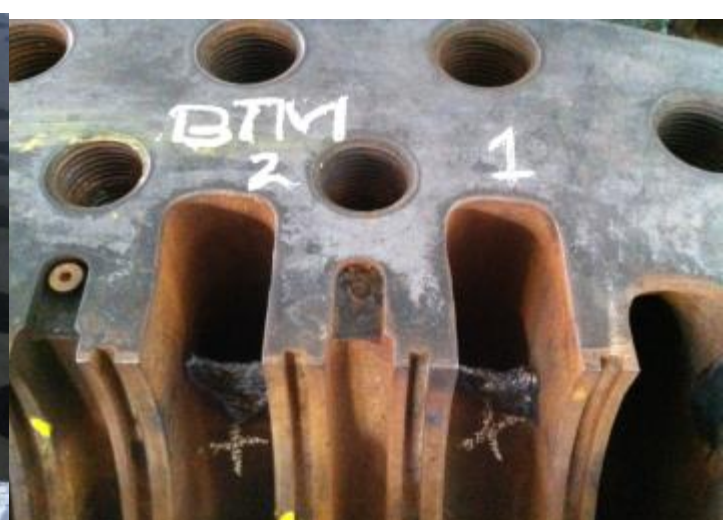
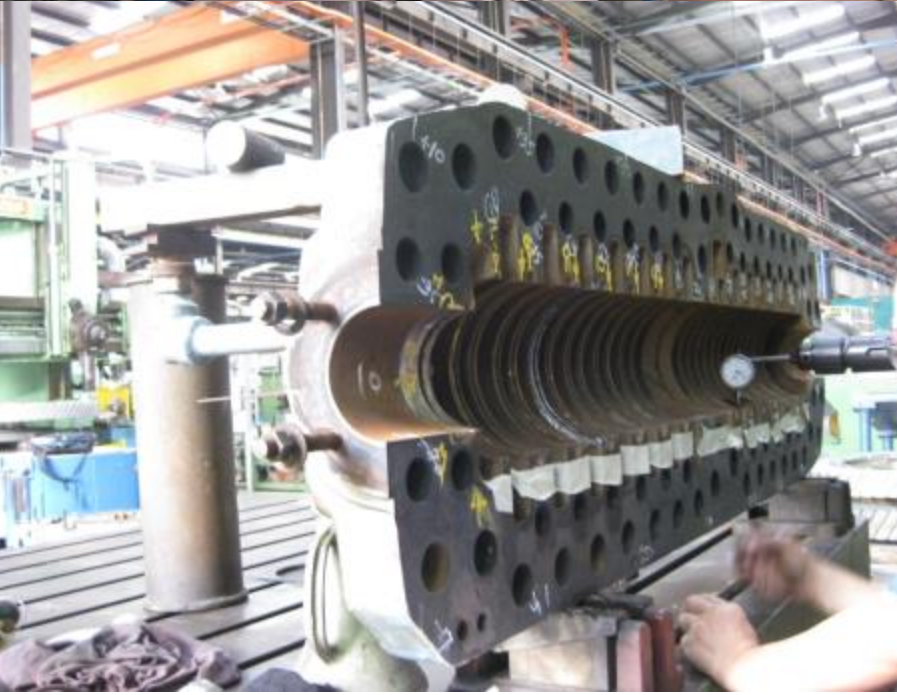
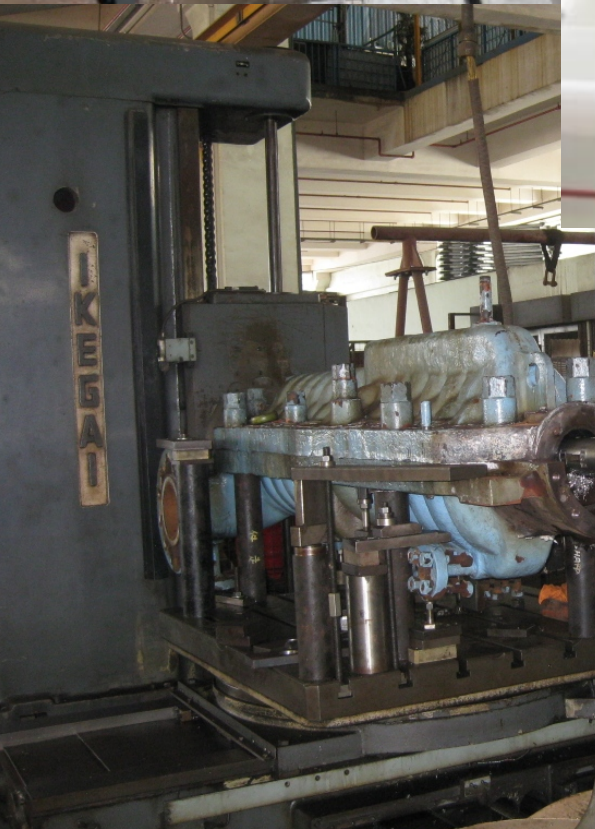
# Extensive repairs

- Casing split machining.
- Centre line boring after build up of worn out areas.
- Repair cracked portions in the casing.
